## REPORT ON CONE PENETROMETER TEST

Client **MAIN ROADS - GATEWAY UPGRADE TEAM**  
Project **GATEWAY UPGRADE**  
Job Ref.  
Location **E 9788.469 N 168755.2**  
Chainage  
Sounding **CPTU166**  
Test Date **3/02/2005**  
Remarks **Augered through surface materials**  
**Water Table was not measured and is assumed.**

Project No. **FG5389**  
Surface RL **3.562**  
Water Table **1.200**  
Start Depth **1.000**  
Refusal **9.725**

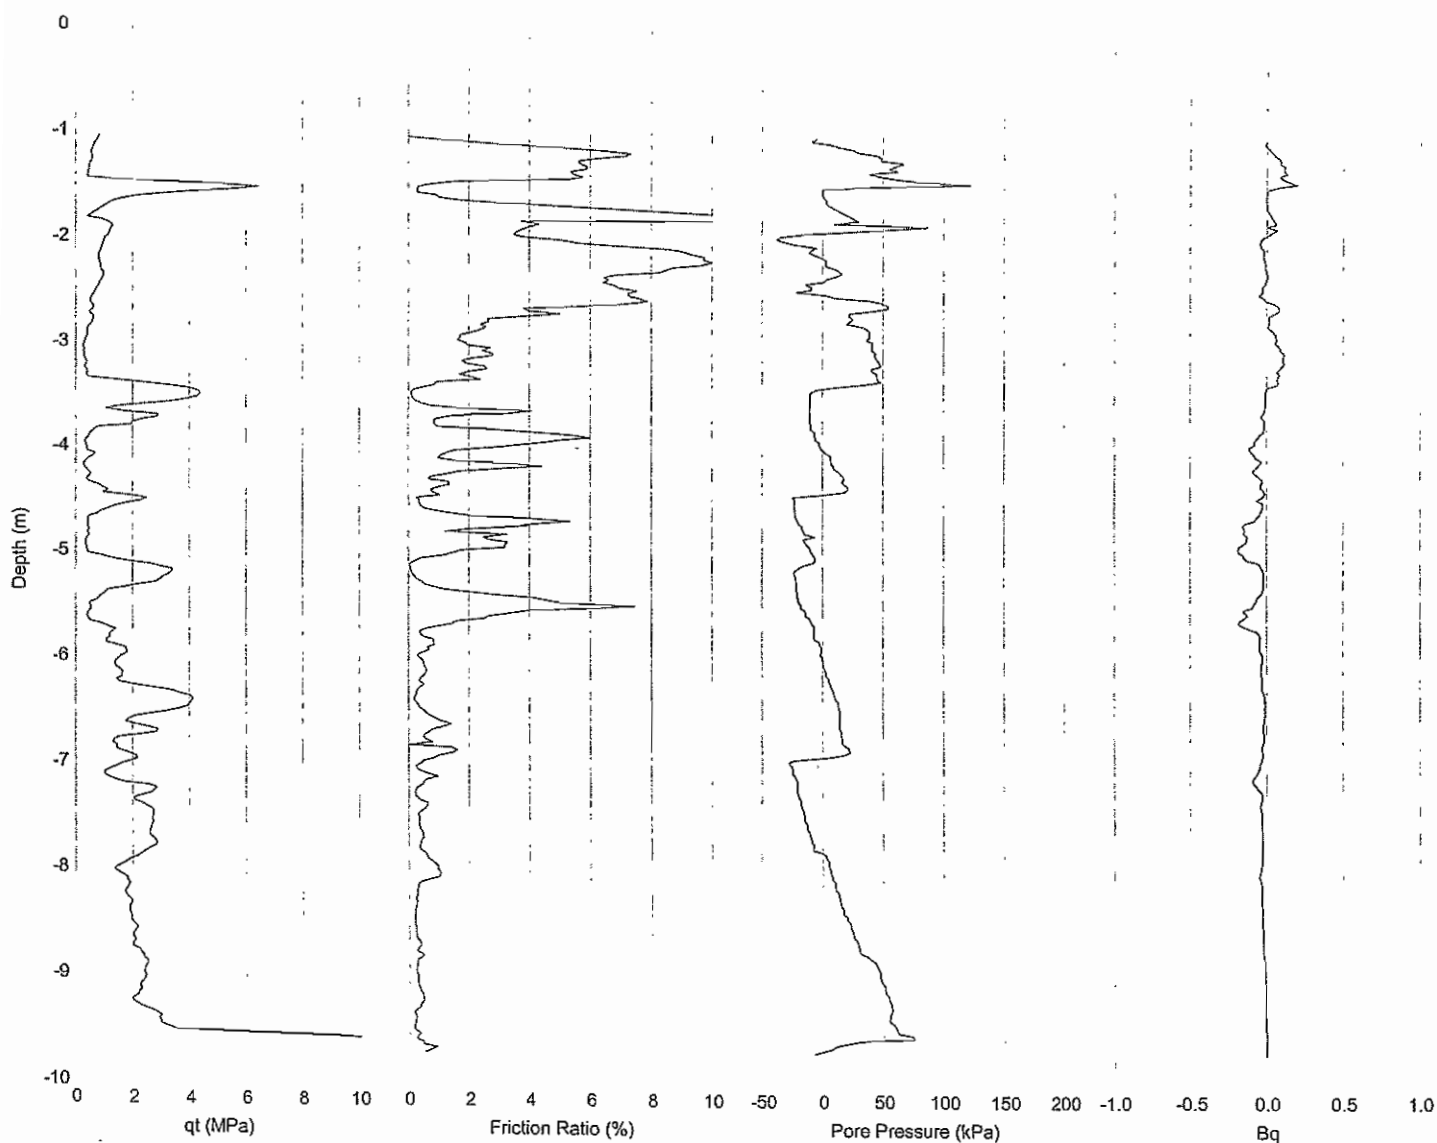
Factor "a"	0.580
		Factor "b"	0.014
		Test Method	Q151A
		Report No.	FG5389/CPTU166/Q151A
