REPORT ON CONE PENETROMETER TEST

Project GATEWAY UPGRADE

Sounding
 CPTU110
 Start Depth
 0.000

Remarks Within bund wall area

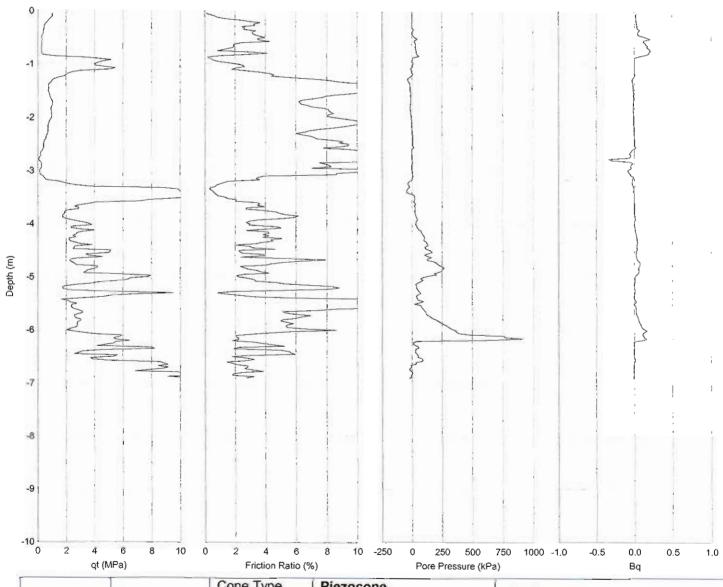
Test Date
 9/06/2004
 Refusal
 6.900

Water Table was not measured and is assumed.

Cone Type	Piezocone	
Date	7/07/2004	Cone ID 31	3167	NATA Accreditation Number 2302 NATA Endorsed Test Report This document may not be reproduced except in full.
Checked	RON	Factor "a"	0.580	
		Factor "b"	0.014	
Signatory	Broke	Test Method	Q151A	
		Report No.	FM2055/CPTU110/Q151A
