ENGINEERING BORELOG

BOREHOLE No : 110
SHEET : 1 OF 3
REFERENCE No : H8636

PROJECT : BRISBANE PORT ROAD STAGE 3
LOCATION : 46895.400E 34448.000N
PROJECT No : C60323 SURFACE R.L. : 1.82 DRILLER : FOUNDRIL PTY LTD
JOB No : DATUM : AHD DATE DRILLED : 22/11/99

BRISBANE PORT ROAD - STAGE 3

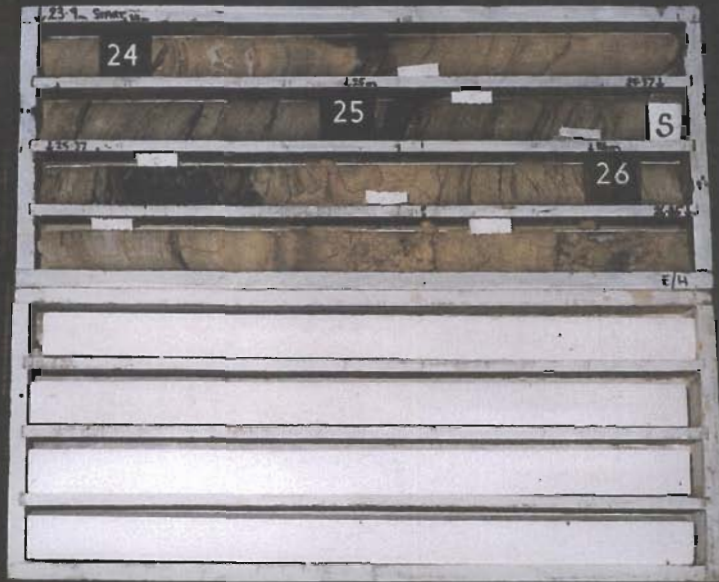
START 23.90
END 26.85
NOV 1999
H8636
BH 110
1OF1

DEPTH (m)	R.L. (m)	AUGER CORE DRILLING CASING OTHER	RQD (%) CORE REC%	SAMPLE	MATERIAL DESCRIPTION	USC WEATHERING	INTACT STRENGTH EH VH H M L	DEFECT SPACING (mm) 20 60 200 600 2000	GRAPHIC LOG	ADDITIONAL DATA AND TEST RESULTS	SAMPLES TESTS
20	-18.18				RESIDUAL SILTY CLAY Pale grey to green, moist, very stiff to hard. Some relic rock structures.	RS				6,12,18 N=30	SPT
21											
22	-19.68				SANDSTONE FINE TO MEDIUM GRAINED, LAMINATED SEDIMENTARY ROCK XW : Generally exhibits engineering properties of pale brown to orange brown moist to dry, hard sandy silt.	XW				9,16,25 N=41	SPT
23	-21.18				HW : Drillers log only.	HW					
24					MW : Pale grey brown to dark grey, fine to medium grained, low to medium strength with occasional high strength bands. Partly carbonaceous; frequent low grade coal seams.					Is (50)=0.28MPa Is (50)=0.58MPa	x x
25			(97) 100		Defects : Lamination partings <40 deg (4/m). Occasional subvertical >75 deg (1/3m).	MW

26	-25.03		(60) 100							Is (50)=0.59MPa	x
27					END OF HOLE						
28											
29											
30
