REPORT ON CONE PENETROMETER TEST

Client **MAIN ROADS - GATEWAY UPGRADE PROJECT TEAM**
Project **GATEWAY UPGRADE**
Job Ref.
Location **E 9387.11 N 172329.96 SET DATUM**
Chainage
Sounding **CPTU151**
Test Date **22/06/2004**
Remarks **Dissipation Test @ 11.0m**

REPORT ON CPT_u DISSIPATION TEST

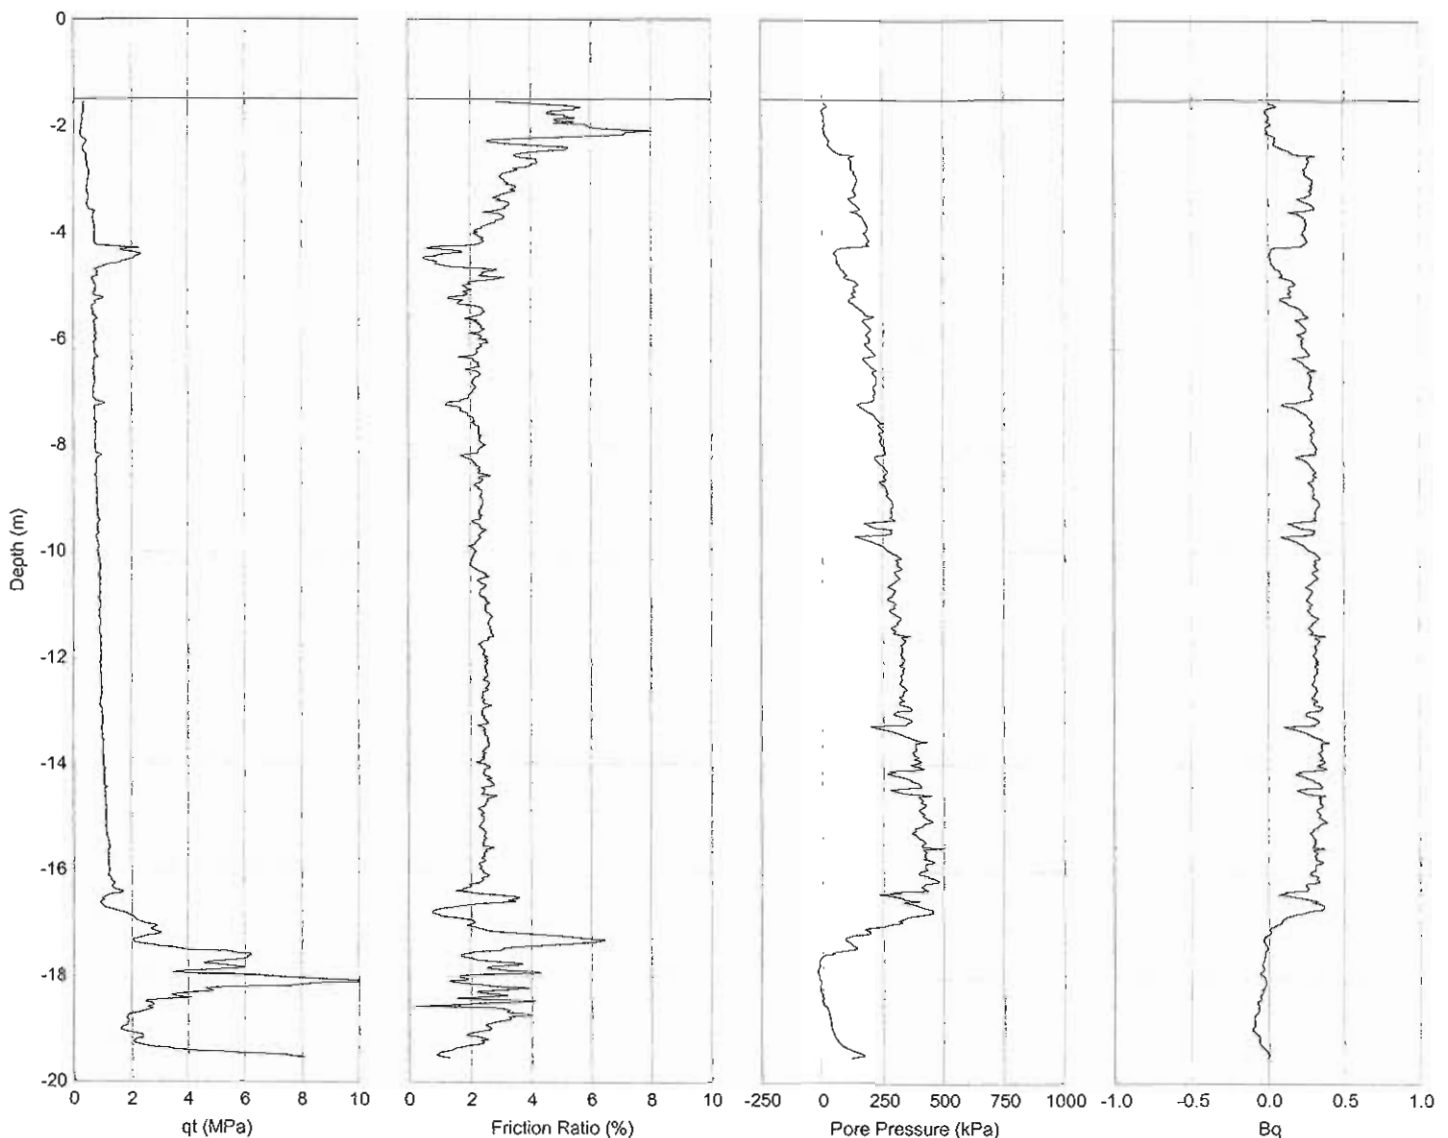
Project No. **FM2055**
Surface RL **1.190**
Water Table **1.200**
Start Depth **1.500**
Refusal **19.550**

Date	8/07/2004	Cone Type	Piezococone
Checked	<i>[Signature]</i>	Cone ID	3167
Signatory	<i>[Signature]</i>	Factor "a"	0.580
		Factor "b"	0.014
		Test Method	Q151A
		Report No.	FM2055/CPTU151/Q151A

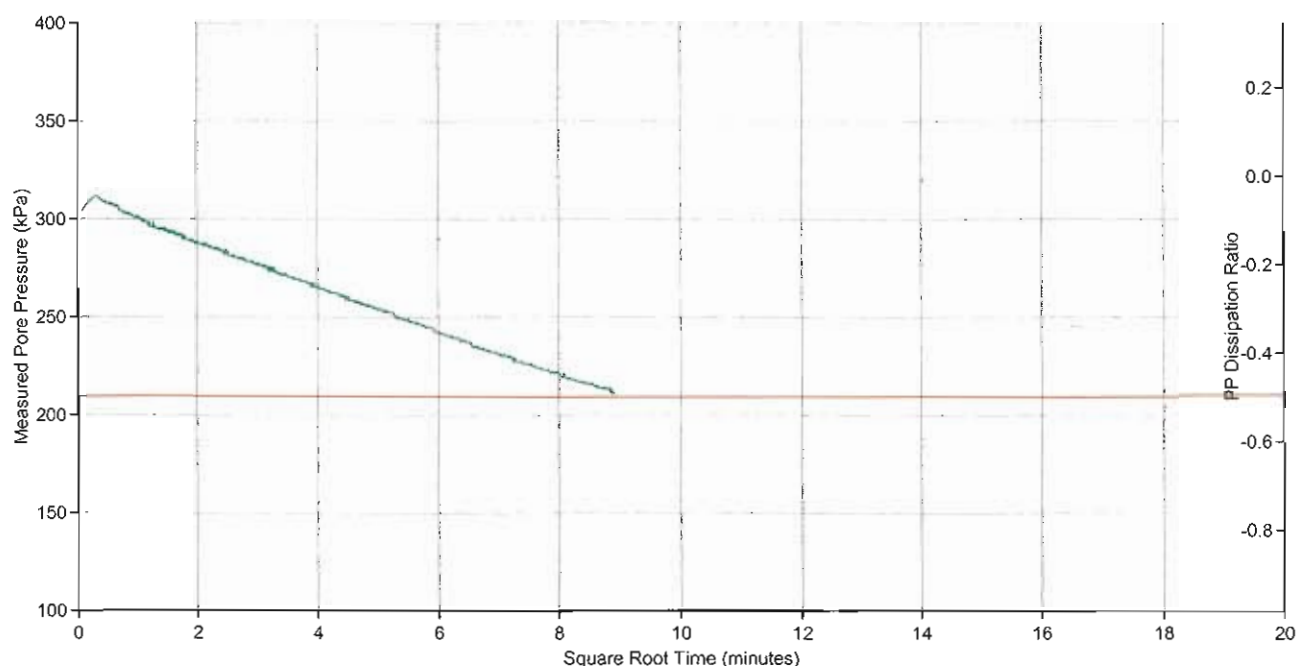
Client **MAIN ROADS - GATEWAY UPGRADE PROJECT TEAM**
Project **GATEWAY UPGRADE**
Job Ref.
Location **E 9387.11 N 172329.96 SET DATUM**
Chainage
Sounding **CPTU151D**
Test Date **22/06/2004**
Remarks **Dissipation Test @ 11.0m**

Project No. **FM2055**
Surface RL **1.190**
Water Table **1.200**
Start Depth **1.500**

Depth (m) **11.01**
Start Pressure (kPa) **322**
Dissipation (%) **50**
Dissipation Pressure (kPa) **209**
Time for Dissipation (min) **81.0**
