# ENGINEERING BOREHOLE

BOREHOLE No	BH103
SHEET	1 of3
REFERENCE No	H9412

PROJ	ECT	GATEWAY UPGRADE PROJECT GEOTECHNICAL INVESTIGATION - NORTHERN SECTION										
LOCA	TION										OORDINATES 9579.0 E; 169069.2 N	
PROJECT No _FM2055			SURFACE R.L3.08	DATE STARTED 3/8/0		1	DATUM <u>SETP</u>					
JOB No		- ^	DATUM <u>AHD</u>		DAT	E COMPLETED	3/8/04	<u> 1</u>	DRILLER R&D Drilling	Pty Ltd_		
о ОЕРТН (т)	R L. (m)	CASING WASH BORING CORE DRILLING	RQD ()% CORE REC%	SAMPLE	MATERIAL DESCRIPTION	LITHOLOGY	USC		DEFECT SPACING (mm)	GRAPHIC LOG	ADDITIONAL DATA  AND  TEST RESULTS	SAMPLES TESTS
-2	1.08				SILTY CLAY - FILL Dark grey, moist, soft to mainly firm.  Frequent dessication and cracks throughout; Medium plasticity.  ESTUARINE (??) SILTY CLAY Dark grey, moist, soft to firm.  High plasticity and some organic content.		OL				1,2,2 N=4 MC=50.4%, WD=1.68t/m3, DD=1.12t/m3	SPT -
5 5 6 6 6 6 6 6 6 6 6 6 6 6 6 6 6 6 6 6	-1.62	A Company of the second of the		No. of the control of	ESTUARINE SILTY SAND Dark grey to grey, wet, very loose. Fine to medium grained sand. (Probable basal layer of the younger/estuarine sediments).		SM				LL=67.2%, PI=35.8%, LS=18.4% APD=2.674t/m3 MC=70.2%, WD=1.60t/m3, DD

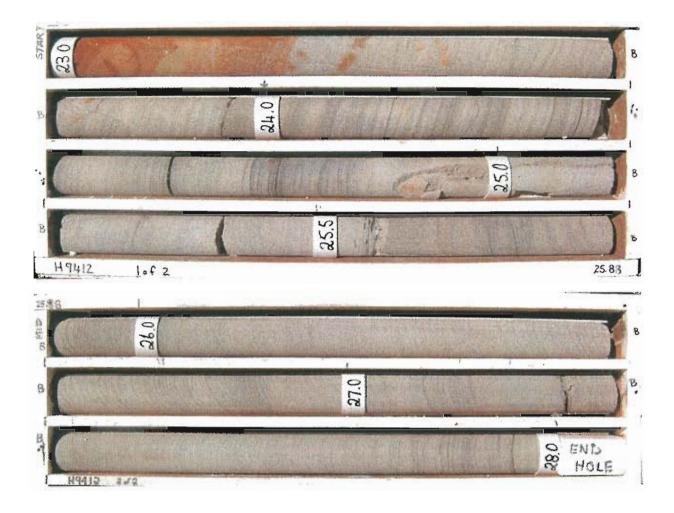
Borehole No: BH 103
Start Depth: 23.00m
Finish Depth: 28.00m
Project No: FM2055
H No: 9412
