## ENGINEERING BOREHOLE LOG

BOREHOLE No BH045

PROJECT BRUCE HIGHWAY (COOROY - CURRA) SECTION A GEOTECHNICAL INVESTIGATION

LOCATION Cut 14

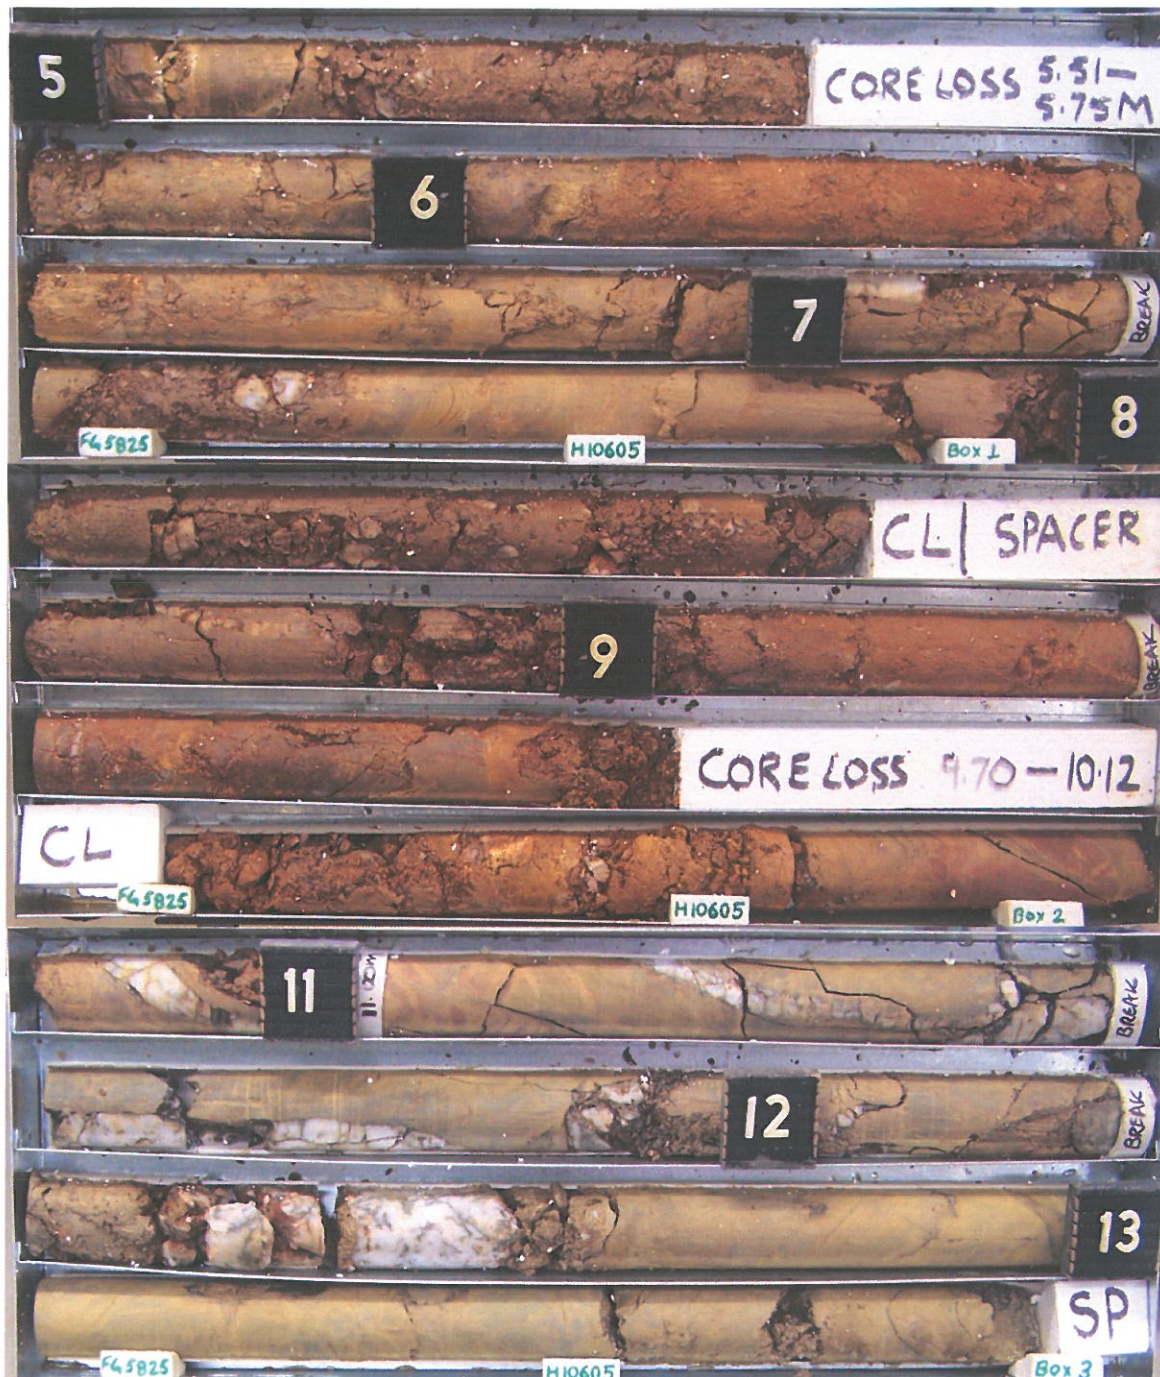
F:GEOT043/1

Project: **Bruce Highway Upgrade (Cooroy – Curra) Section A**  
Borehole No: **BH45**  
Start Depth: 5.00m  
Finish Depth: 20.35m  
Project No: FG5825  
H No: 10605

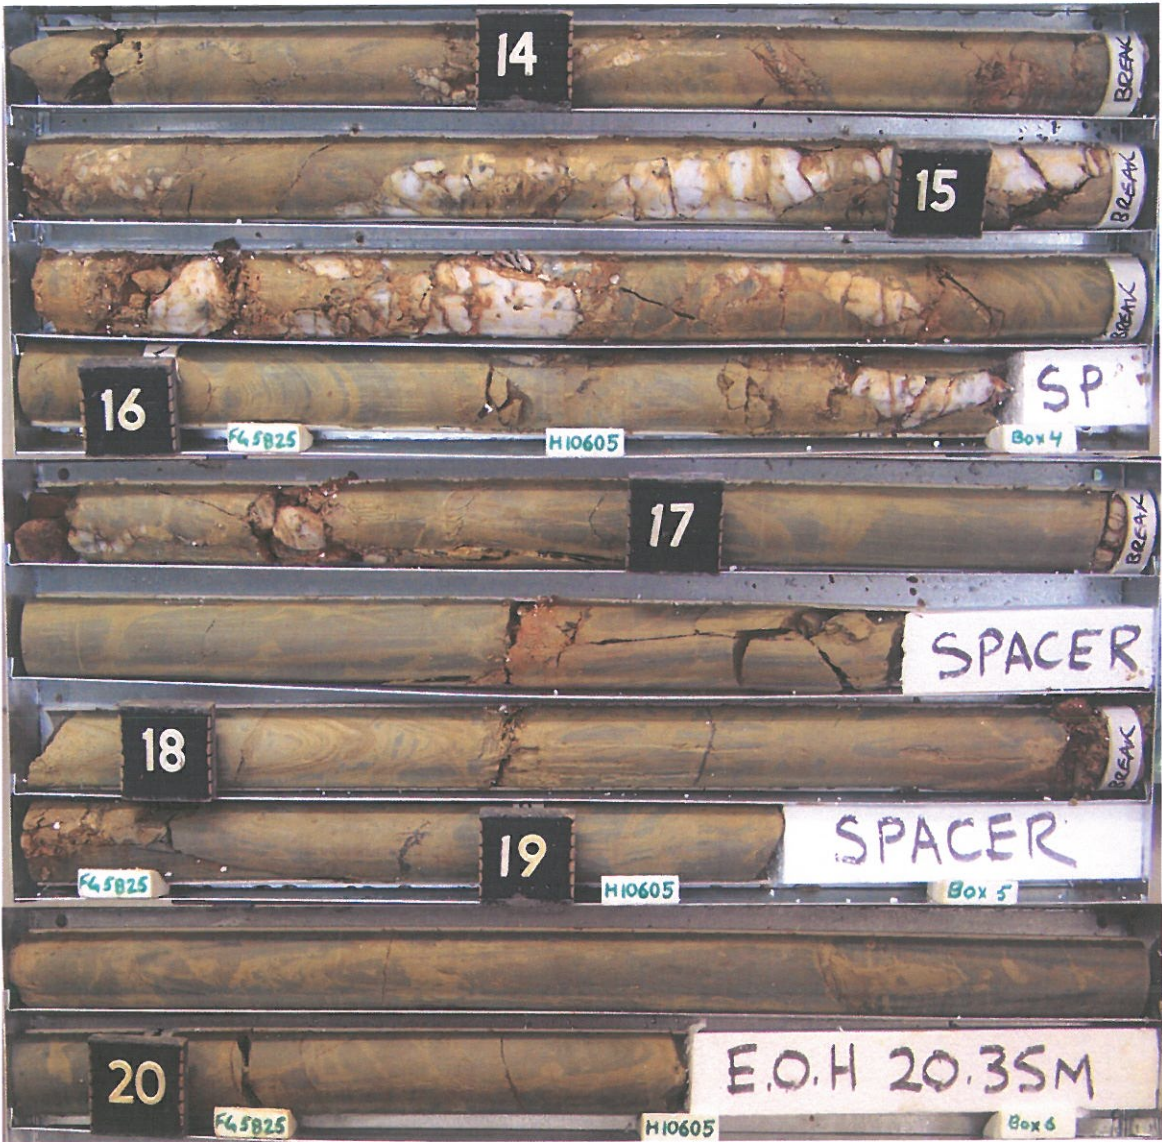
F:GEOT043/1

Project: **Bruce Highway Upgrade (Cooroy – Curra) Section A**  
Borehole No: **BH45**  
Start Depth: 5.00m  
Finish Depth: 20.35m  
Project No: FG5825  
H No: 10605
