# ENGINEERING BOREHOLE LOG

BOREHOLE No BH601  
SHEET 1 of 5  
REFERENCE No 11570

PROJECT Townsville Ring Road Section 4 Dalrymple Overpass  
LOCATION Dalrymple Overpass COORDINATES 467143.7 E; 7867017.0 N  
PROJECT No FG 6020 SURFACE R.L. 16.62m PLUNGE \_\_\_\_\_ DATE STARTED 5/9/13 GRID DATUM MGA94 Zone 55  
JOB No \_\_\_\_\_ HEIGHT DATUM AHD BEARING \_\_\_\_\_ DATE COMPLETED 7/9/13 DRILLER Cairns Drilling Pty Ltd

# CORE PHOTO LOG

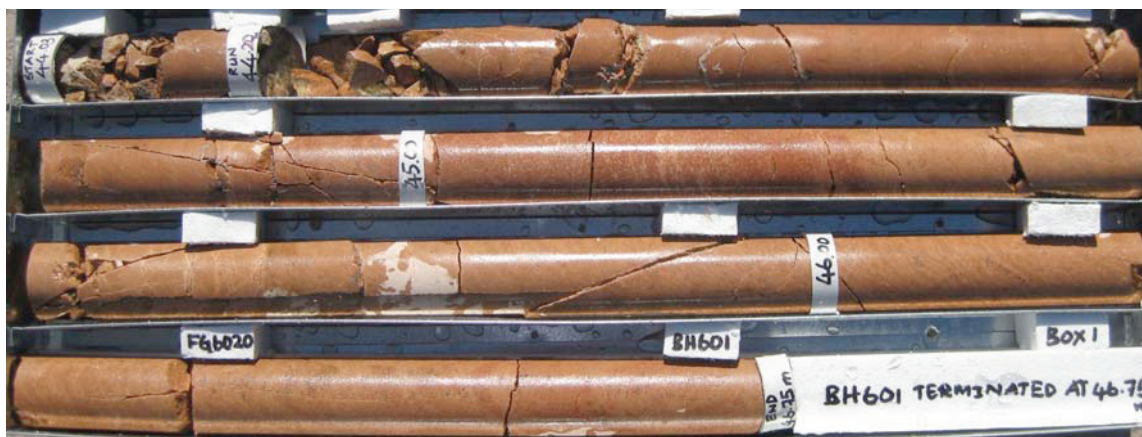
| Borehole No | BH 601 | TMR H No | 11570 |
| Location | Dalrymple Overpass | Start Depth (m) | 44.03 |
| Detail | | Finish Depth (m) | 46.75 |

| DEPTH (m) | R.L. (m) | AUGER WASH BORING CORE DRILLING | RQD ( ) % | CORE REC % | SAMPLE | MATERIAL DESCRIPTION | LITHOLOGY | USC WEATHERING | INTACT STRENGTH | DEFECT SPACING (mm) | GRAPHIC LOG | ADDITIONAL DATA AND TEST RESULTS | SAMPLES TESTS |
|---|---|---|---|---|---|---|---|---|---|---|---|---|---|
| 44 | -27.43 | | | | AE | <b>SW:</b> Pink, orange, fine to medium grained, massive, high strength. Defects: -Joints at 0°-5° (1/m) -Joints at 15°-25° (2/m) -Joints at 60°-70° (2-3/m) -Joints at 80° (2/m) Defects are generally medium spaced, planar, rough, open and clay coated. | SW | | | | | 30/30 N>50 | SPT |
| | | | (0)<br>100<br>(29) | | | | | | | | | Broken Zone<br>44.2m: Partial water loss. | |
