ENGINEERING BOREHOLE LOG

BOREHOLE No BH C75

PROJECT	Bruce Highway Upgrade (Cooroy to Curra) Section C										
LOCATION									OORDINATES <u>470832.0 E; 7096472.</u>	<u>4 N</u>	
PROJECT No	FG5799			SURFACE R.L. <u>76</u> .20m PLUNGE			DATE \$	TARTED _	<u>//11</u> GRID DATUM <u>MGA94</u>		
JOB No	232/	10 <u>A</u> /2		HEIGHT DATUM _AHD BEARING DATE COMPLETED 30/08				0/11 DRILLER <u>Drillsure Pty</u> L	.td		
R.L. (m) HELL 430 0 76.20	AUGER CASING WASH BORING CORE DRILLING	RQD ()% CORE REC%	SAMPLE	MATERIAL DESCRIPTION TOPSOIL	LITHOLOGY	USC	INTACT STRENGTH	DEFECT SPACING (mm)	GRAPHIC LOG	ADDITIONAL DATA AND TEST RESULTS	SAMPLES

CORE PHOTO LOG - BH C75

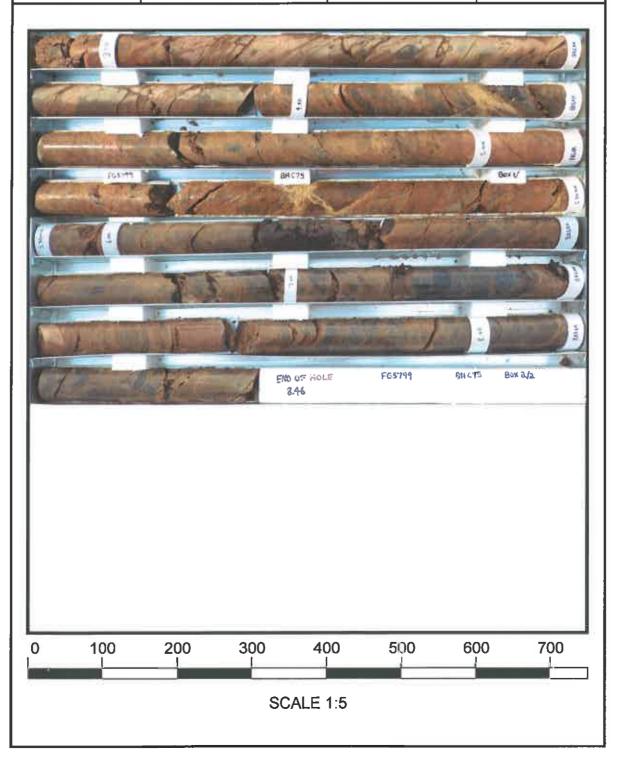
Project Name:	BRUCE HIGHWAY UPGRADE - SECTION C						
Project No.:	FG5799	Date:	08/09/2011				
Details:	Structure	Start Depth (m):	2.90				
Reference No.:	H11150	Finish Depth (m):	8.46
