ENGINEERING BOREHOLE LOG

BOREHOLE No BH13
SHEET 1 of 2
REFERENCE No H11023

PROJECT Moreton Bay Rail Link
LOCATION Cut 4, Ch.5520 COORDINATES 502547.2 E; 6986126.6 N
PROJECT No FG5921 SURFACE R.L. 26.60m PLUNGE DATE STARTED 12/5/11 GRID DATUM MGA94 Zone 56
JOB No 250/120/3 HEIGHT DATUM AHD BEARING DATE COMPLETED 12/5/11 DRILLER R&D Drilling Pty Ltd

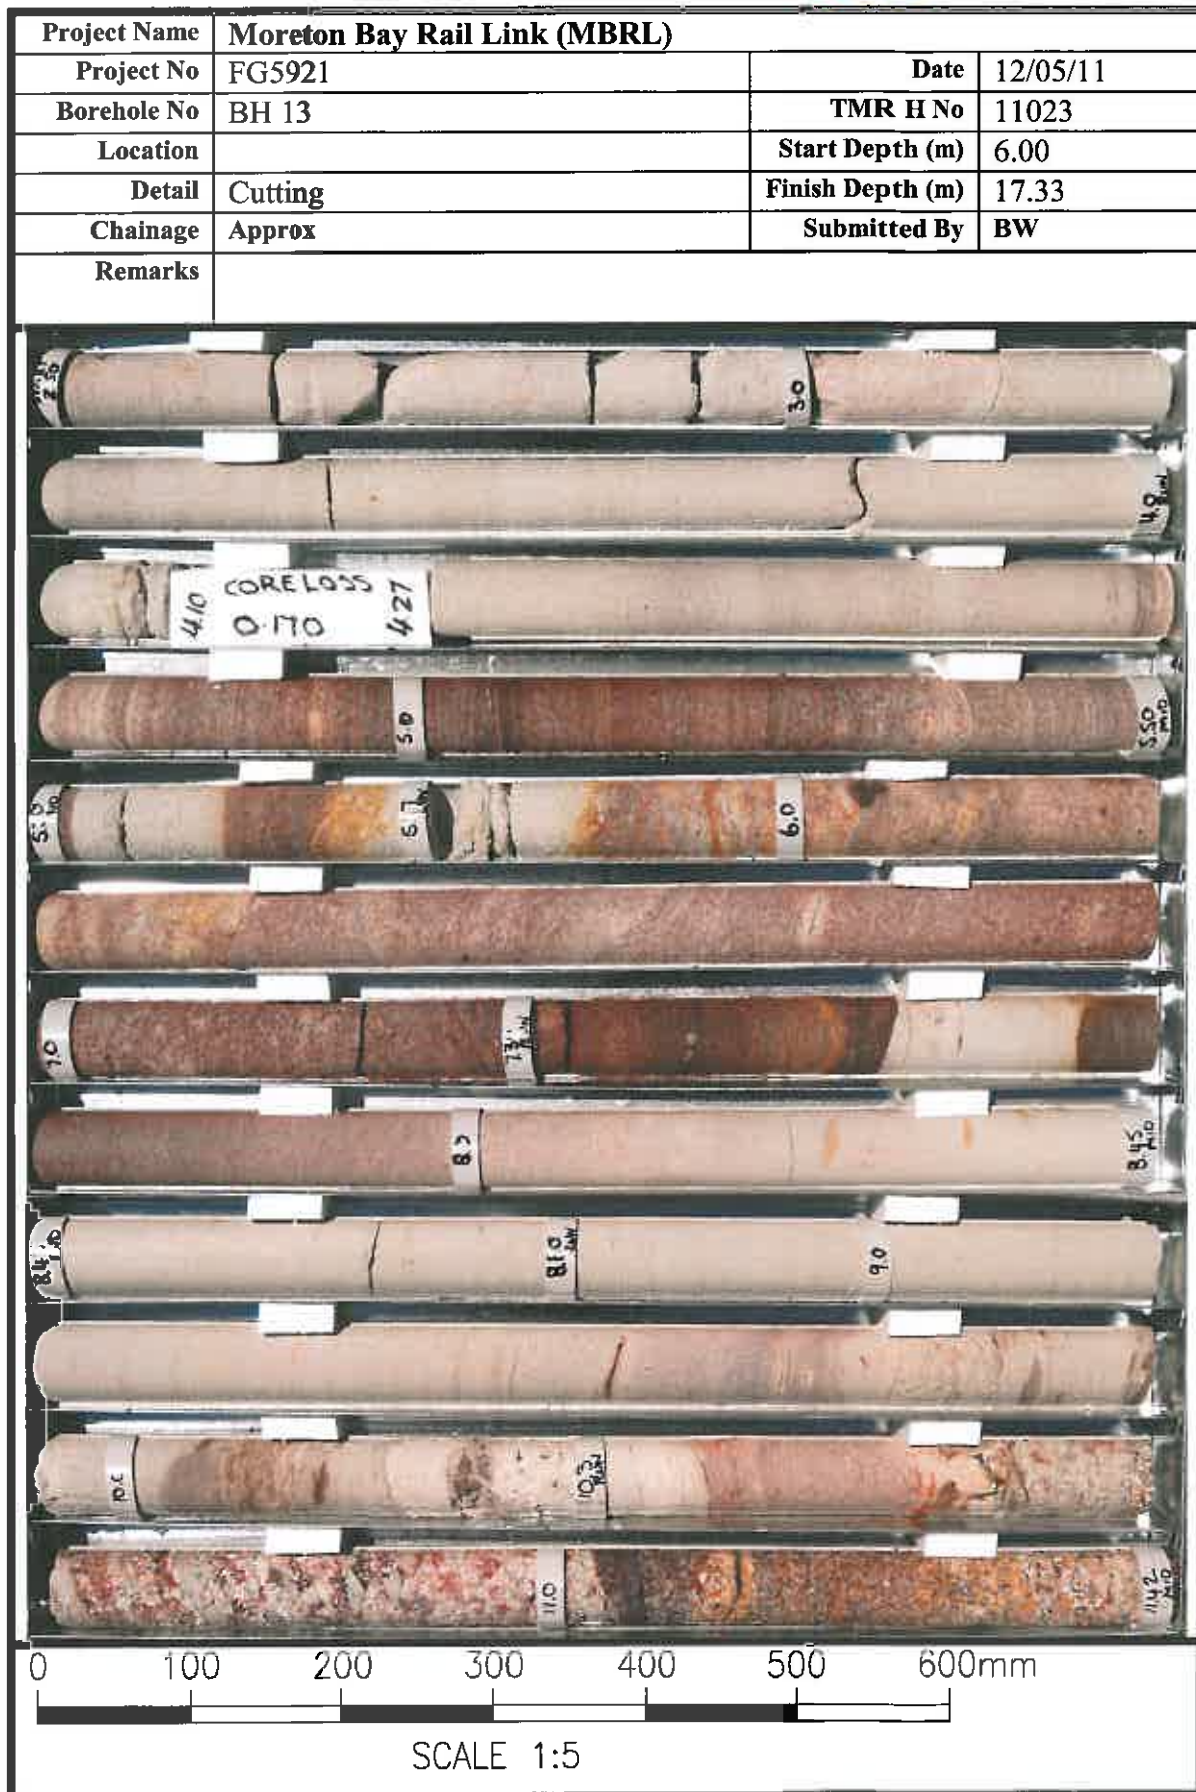
Project Name	Moreton Bay Rail Link (MBRL)		
Project No	FG5921	Date	12/05/11
Borehole No	BH 13	TMR H No	11023
Location		Start Depth (m)	2.50
Detail	Cutting	Finish Depth (m)	17.33
Chainage	Approx	Submitted By	BW
Remarks
