ENGINEERING BOREHOLE

BOREHOLE No **BH29**
SHEET **1** of **4**
REFERENCE No **H9578**

PROJECT GATEWAY BRIDGE DUPLICATION FOUNDATION INVESTIGATION - GATEWAY UPGRADE PROJECT
LOCATION PIER 17 - DOWN STREAM END COORDINATES 9857.2 E; 168660.0 N
PROJECT No FG5388 SURFACE R.L. 3.10 DATE STARTED 08/02/05 DATUM SETP
JOB No DATUM AHD DATE COMPLETED 08/02/05 DRILLER R&D DRILLING PTY LTD

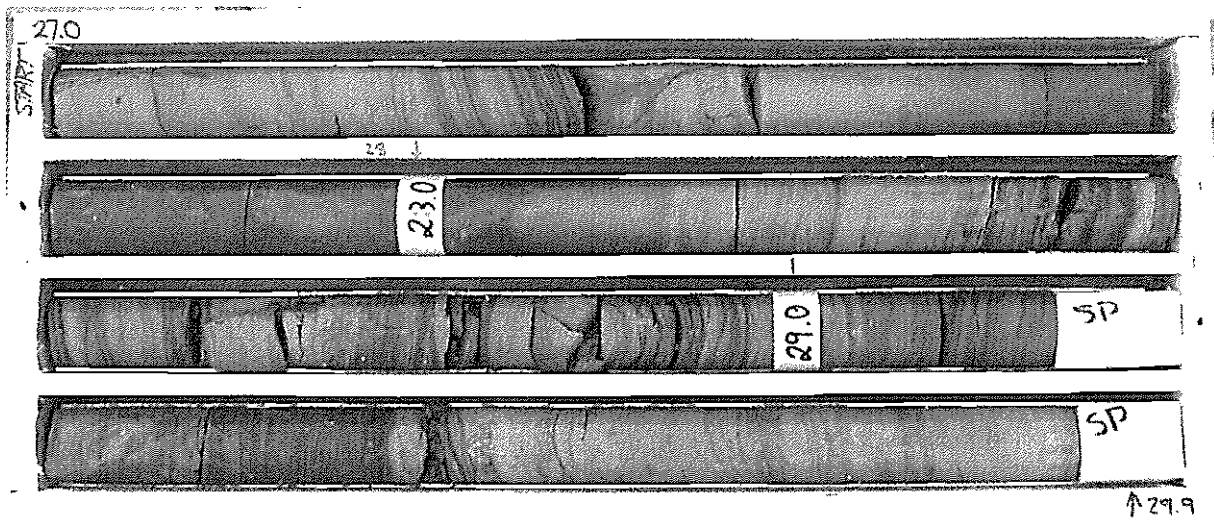
Borehole No: **BH 29**

Project: **Gateway Bridge Duplication Investigation**

Start Depth: 27.00m

Finish Depth: 29.90m
