# ENGINEERING BOREHOLE LOG

BOREHOLE No BH C71

PROJECT Bruce Highway Upgrade (Cooroy to Curra) Section C

LOCATION Embankment 1/Traveston Creek Bridge Abut B COORDINATES 473365.0 E; 7088048.5 N

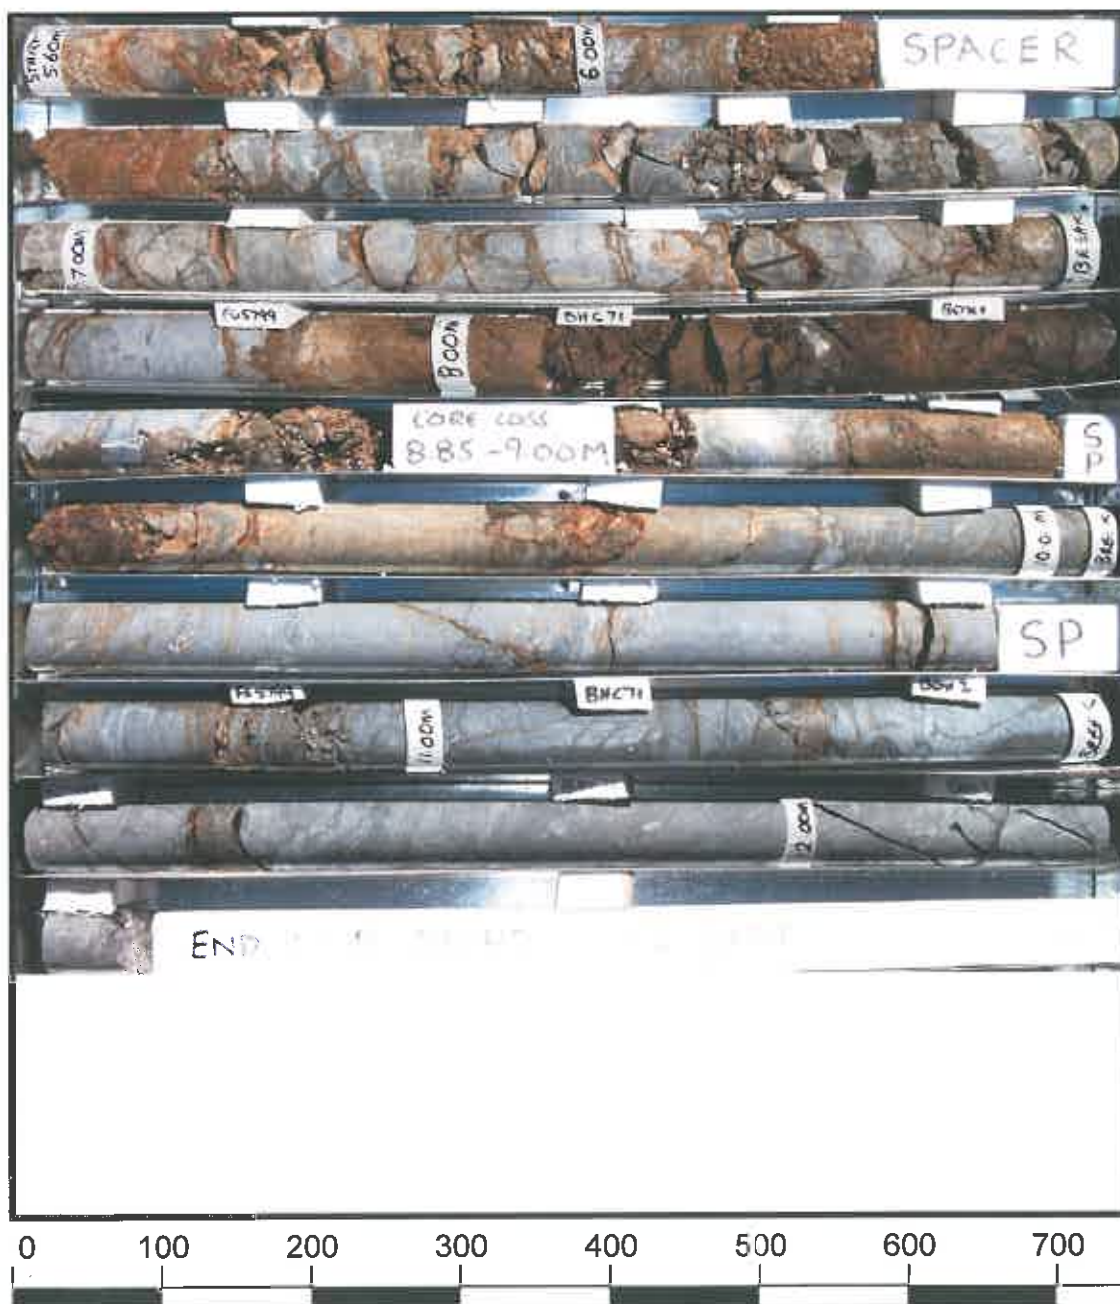
## CORE PHOTO LOG - BH C71

Project Name:	BRUCE HIGHWAY UPGRADE - SECTION C		
Project No.:	FG5799	Date:	15/09/2011
Details:	Structure	Start Depth (m):	5.60
Reference No.:	H11240	Finish Depth (m):	12.31
