REPORT ON  
ELECTRIC FRICTION-SLEEVE CONE PENETROMETER  
Test Method No. QMRD 151(B)

MAIN ROADS  
Materials Branch, Herston  
Geomechanical Services  
REPORT No.2-407SE 918

PROJECT GATEWAY ARTERIAL

SOUNDING No. CP64

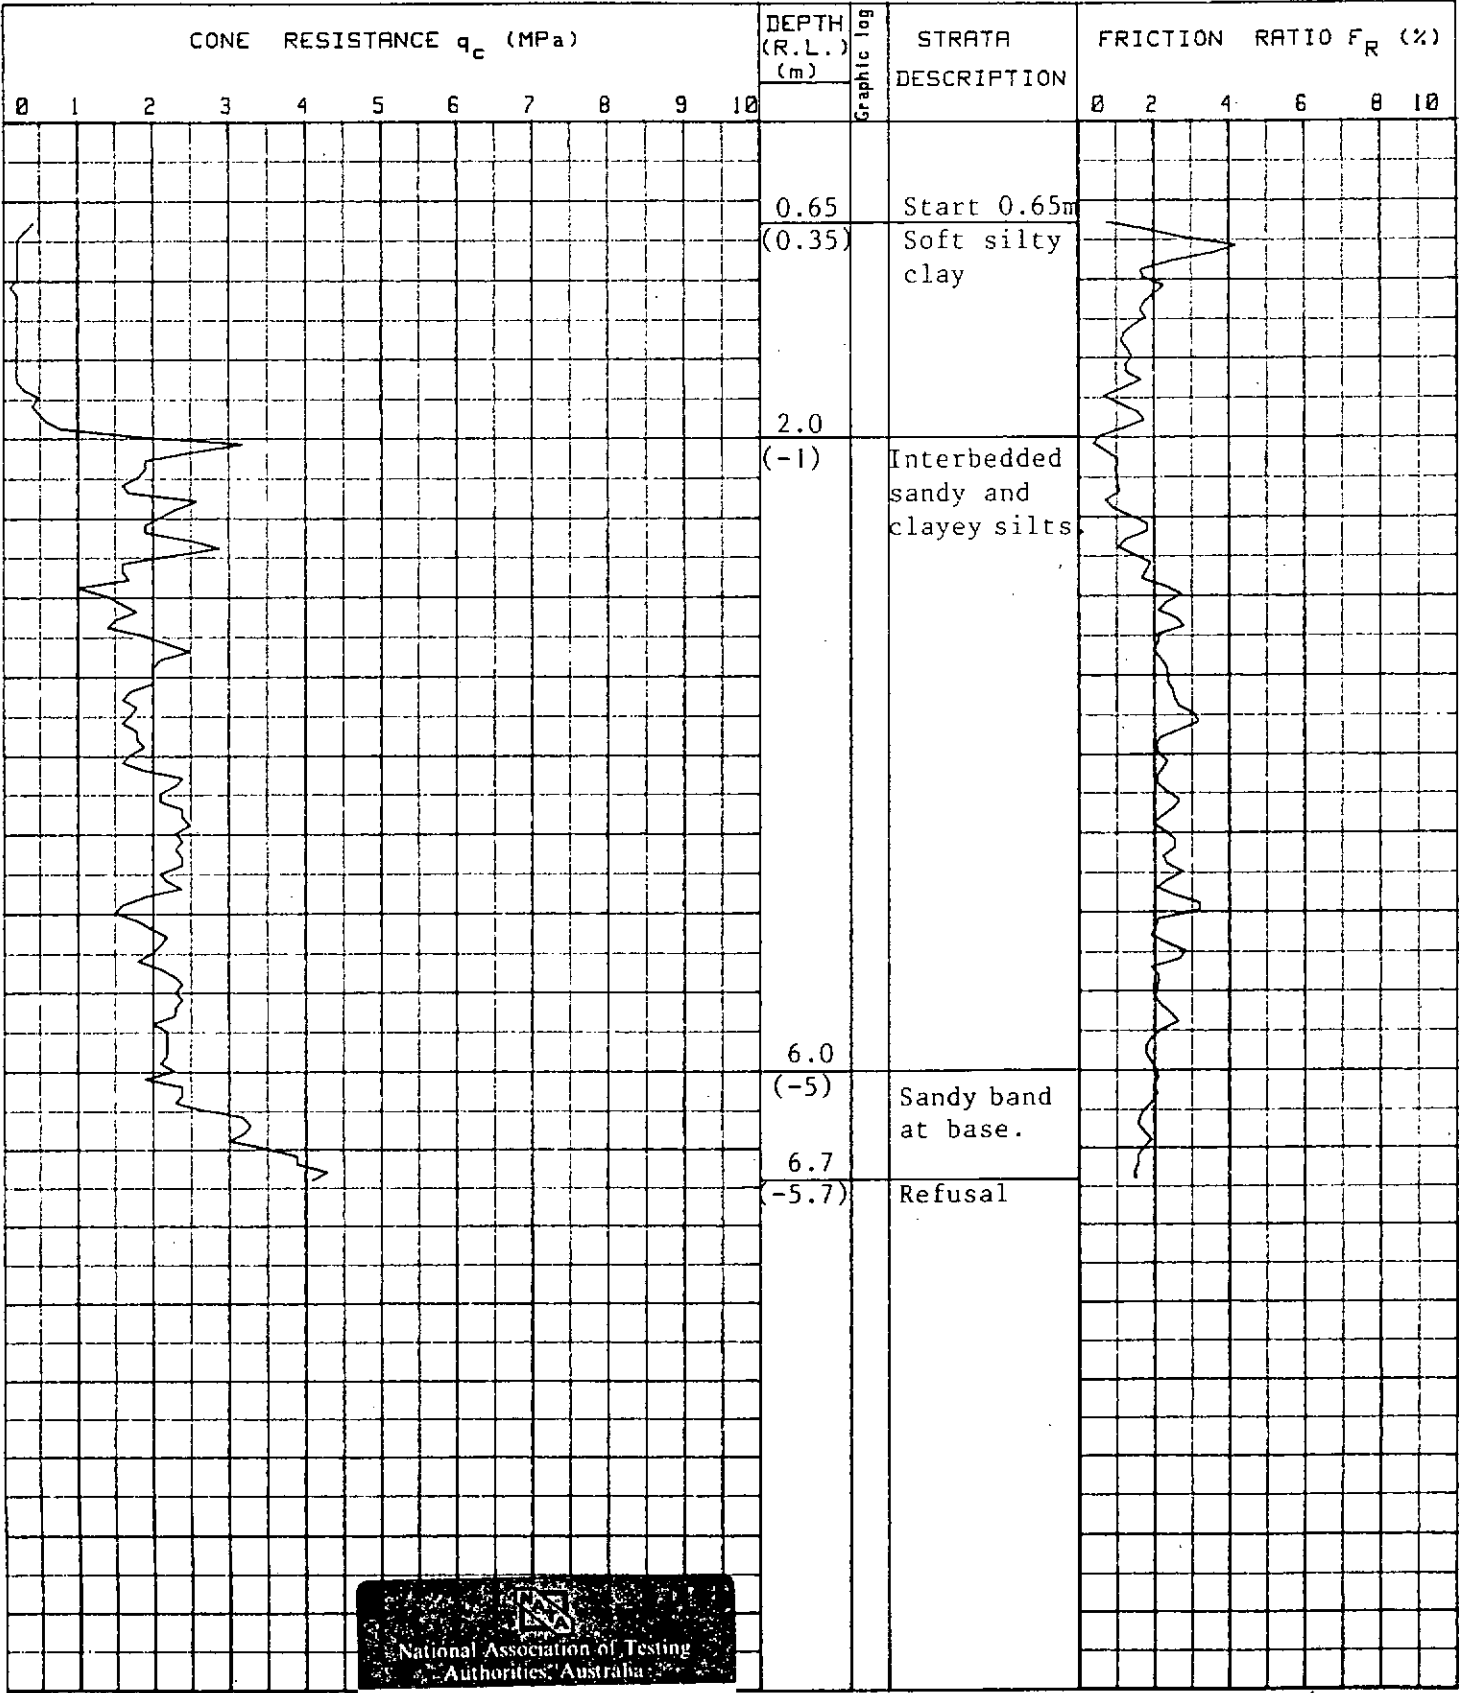
LOCATION E 42300.304, N 44331.093  
at approx. Ch. 5577.5

SURFACE RL 1 m
