ENGINEERING BOREHOLE LOG

BOREHOLE No BH10
SHEET 1 of 2
REFERENCE No H11020

PROJECT Moreton Bay Rail Link
LOCATION Bridge over Bruce Hwy, Abutment A, Bridge 6, Ch.4732 COORDINATES 501815.5 E; 6985822.6 N
PROJECT No FG5921 SURFACE R.L. 10.30m PLUNGE DATE STARTED 10/5/11 GRID DATUM MGA94 Zone 56
JOB No 250/120/3 HEIGHT DATUM AHD BEARING DATE COMPLETED 10/5/11 DRILLER R&D Drilling Pty Ltd

Project Name	Moreton Bay Rail Link (MBRL)		
Project No	FG5921	Date	10/05/11
Borehole No	BH 10	TMR H No	11020
Location	Bridge over Bruce Hwy	Start Depth (m)	4.00
Detail	Structure	Finish Depth (m)	18.21
Chainage	473029 Approx	Submitted By	BW
Remarks

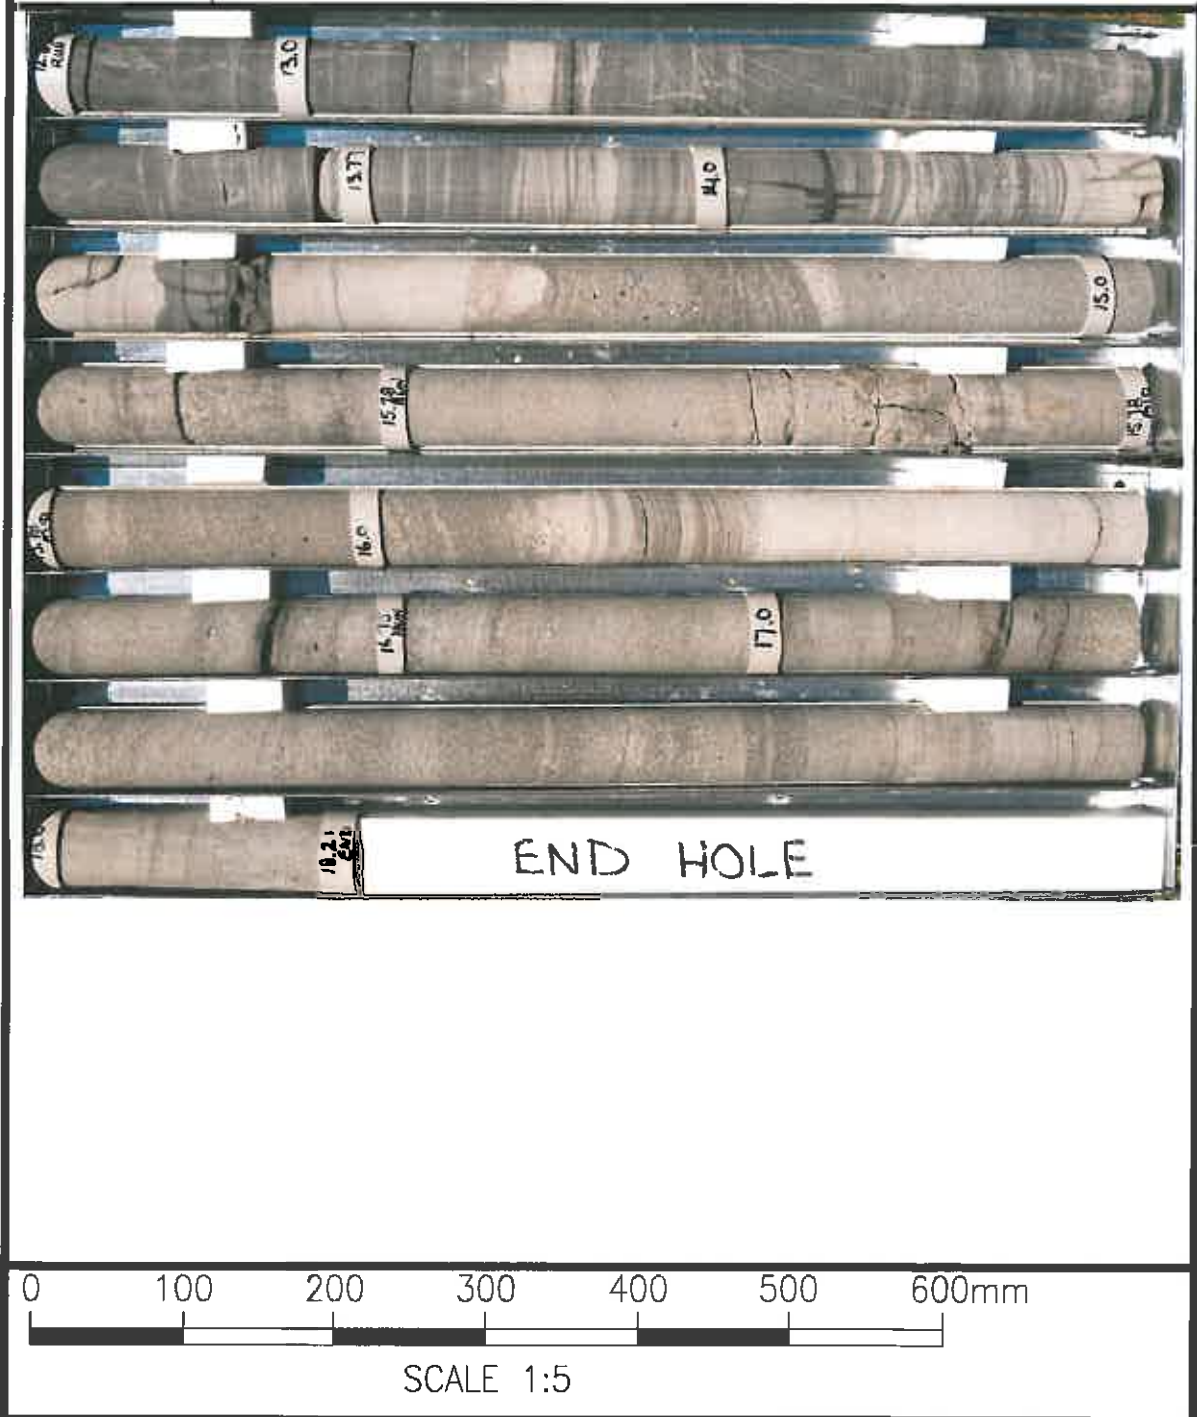
Project Name	Moreton Bay Rail Link (MBRL)		
Project No	FG5921	Date	10/05/11
Borehole No	BH 10	TMR H No	11020
Location		Start Depth (m)	4.00
Detail	Structure	Finish Depth (m)	18.21
Chainage	1030 Approx	Submitted By	BW
Remarks
